\$15
 Number 80   2024
www.ccj-online.com

Features

Five plants earn CCJ's 2024 Best of the Best honor.....	3
ASME accords Kansas combined cycle Historic Landmark status.....	58
Latest case studies on use of film-forming substances in powerplants.....	64
Effect of hydrogen combustion on thermal barrier coatings.....	69
Software-as-a-service diagnostics underscores whole-of-plant approach.....	72
Avoid Stellite delamination with alternative hardfacing	75
Persistence key to finding gremlin impacting starting reliability	77
How exhaust-gas distribution can affect SCR performance.....	79
HRSG need not be a limiting factor in GT upgrade.....	81
2025 industry user group meeting calendar	83

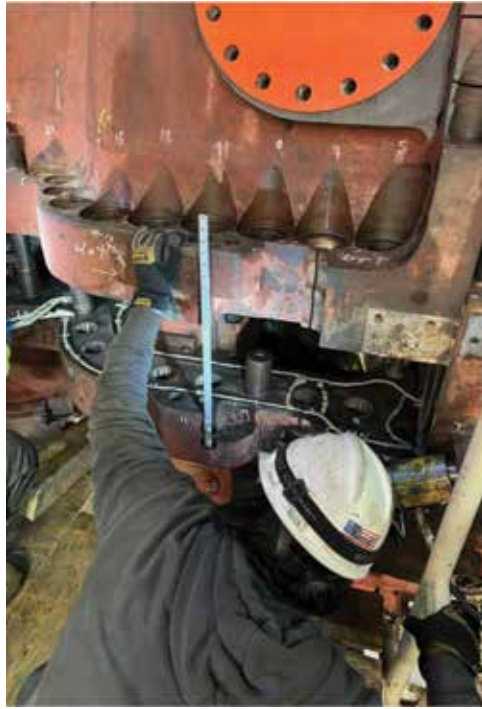
Hands-free measurement during casing lifts

Simple to make in the plant shop with self-adhesive measuring tape, aluminum bar stock (0.125 × 0.750 × 48 in. recommended), and 18-lb rubber-coated magnets. How: Cut aluminum to 24 in. and chamfer sharp edges; bend offset so measurement section remains flush against the case; install measuring tape with zero at the start of the flush section. Benefit: Hands-free measurement during turbine case removal and install, thereby protecting personnel.

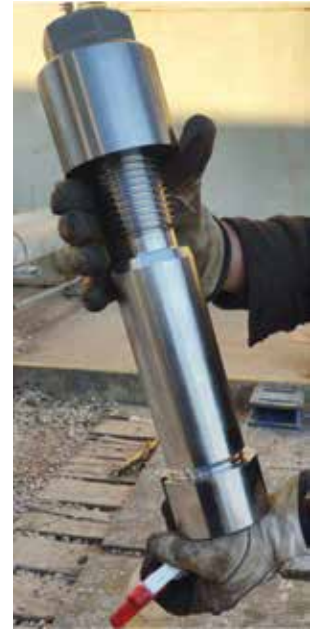
Use of Siemens-Energy’s upgraded hardware facilitates removal and replacement of generator coupling bolts, nuts

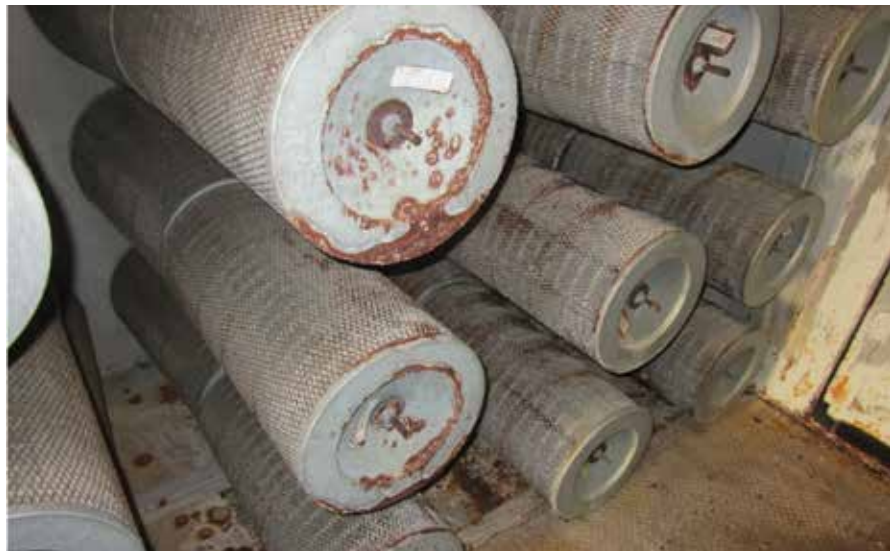
Maintain the clean side of your filter house to avoid throwing away time and money on filter changeouts

Good filtration, plus the condition of your filter house, inlet, bellmouth, and inlet guide vanes, are important to the overall health and performance of your gas turbine. Virtually all experienced operations personnel know this, but some technicians are prone to taking shortcuts and some supervisors are not as hard-nosed as they might be.

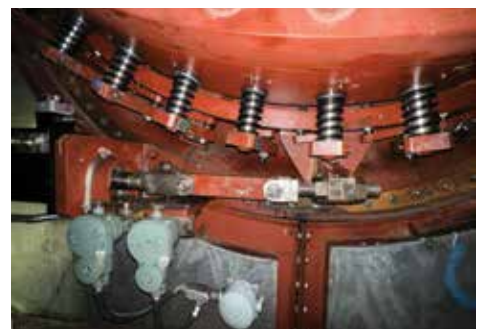
Remember to verify linkage thrust force after lubricating your IGVs

Lubricate inlet guide vanes during your annual borescope inspections

This maintenance and troubleshooting guide for M501F inlet guide vanes includes a few slides pertaining to the W501, so it's representative of the 501F fleet. The editors rate the presentation “valuable” for its detail, recommending it be included in the plant O&M library.

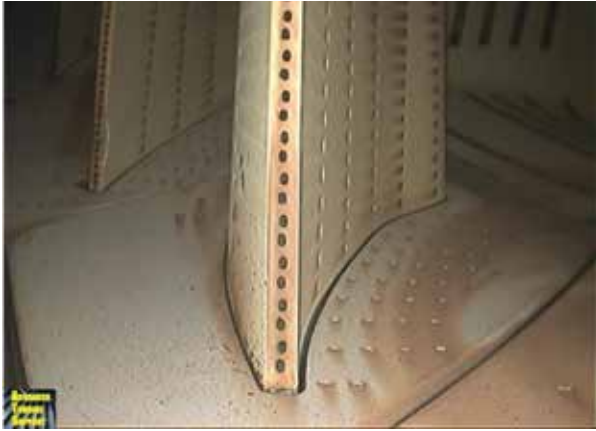
Advanced first-stage vanes in GTOP system remain pristine after two years of service

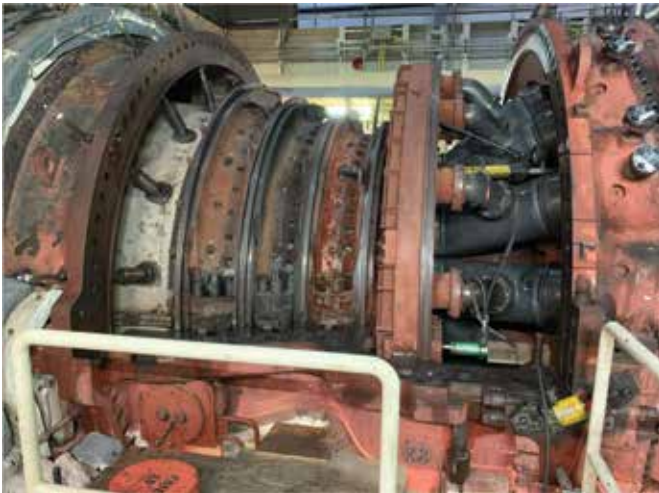
Loss of finger seals early in life of this FlameSheet combustor was surprising

Several flashback events were recorded, requiring removal and disassembly of all cans as described in photographs. All finger seals were replaced along with six flow sleeves.

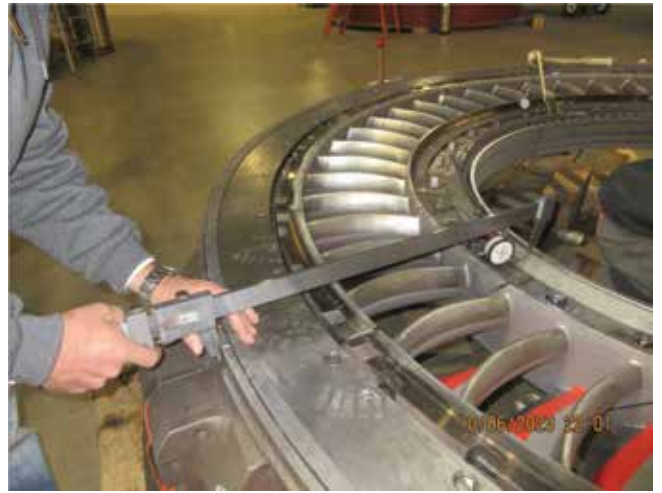
Excessive base-metal oxidation in Rows 2 and 3 encouraged the unit owner to plan for blade-ring exchanges

Row 2 turbine blade ring for No. 8 was exchanged during the unit's 2019 HGP because of excessive base-metal oxidation and circumferential deformation. R3 had significant oxidation throughout the entire blade ring but was only weld-repaired. On the sister unit's (No. 7) major in 2020, R2 was exchanged because of severe base-metal oxidation and material loss while R3 distortion was corrected in the OEM's shop. Based on this experience, the utility planned to replace the R2 and R3 blade rings during the Unit 8 major.

Outage-planning highlights and notes and photos of the as-found condition of R2 and R3 for Unit 8 are provided in the slides, along with blade-ring assembly challenges important to users with similar issues.

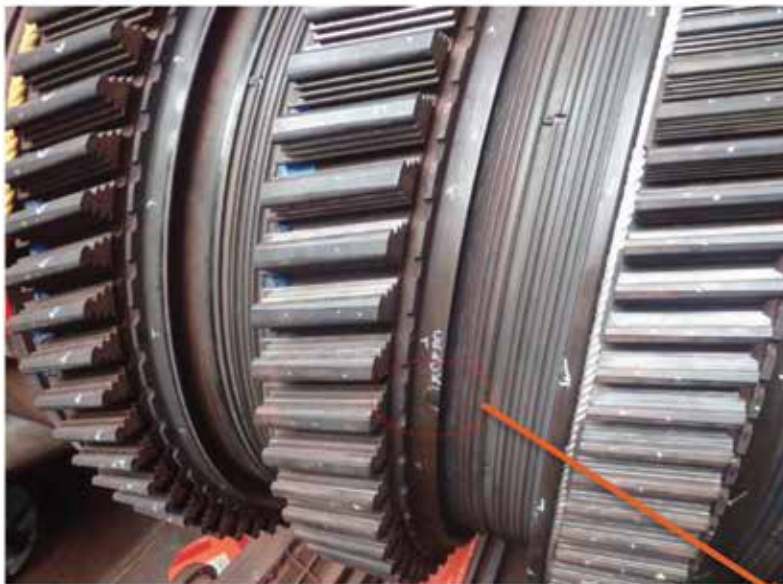
Rotor alignment was one of the challenges faced after replacing Row 3 interstage seals

Interferences between the geometry of the ring-segment retaining lugs and blade rings were found as well and are discussed, in addition to issues with the blade-ring horizontal ledge keys that prevented horizontal joints from closing properly. R3 interstage seal alignment was another problem encountered. It made rotor alignment difficult and was resolved by sacrificing side-to-side spindle clearances.

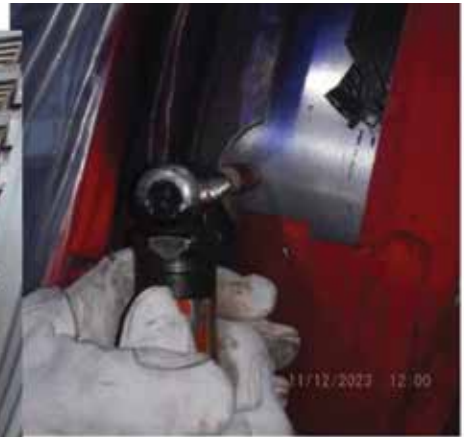
Crack found in Row 2 was excavated, then blended using a 5:1 ratio

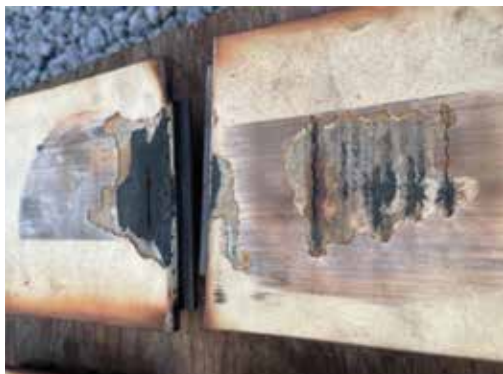
Damage to Row 1 ring segment was an emergent issue faced during unit's first HGPI

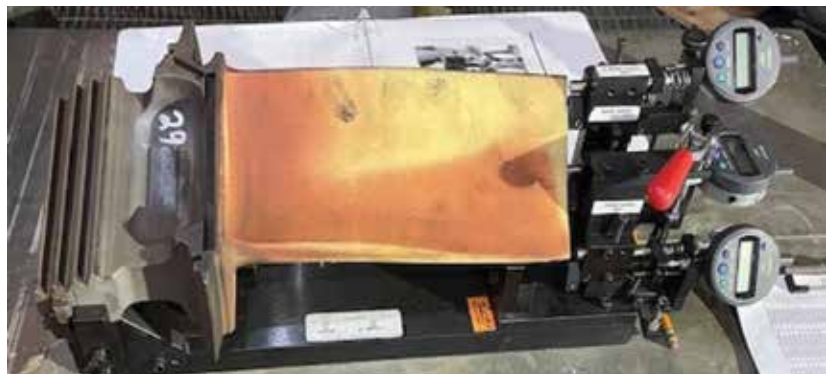
Field tipping of Row 1 blades was cited for dealing with rubs

Causes of rubs and ways to prevent them are discussed. Takeaways on how clearances are checked and calculated, plus the process and hygiene of tipping, are focal points

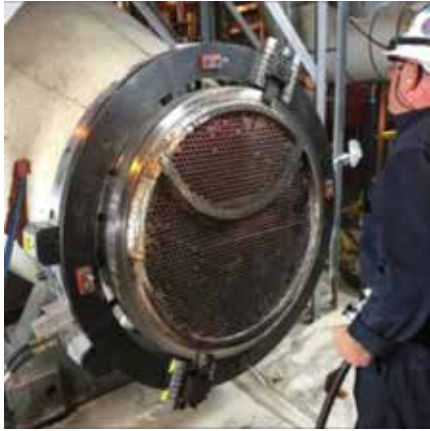
Machining the face of the tubesheet helped restore the condition of this kettle boiler

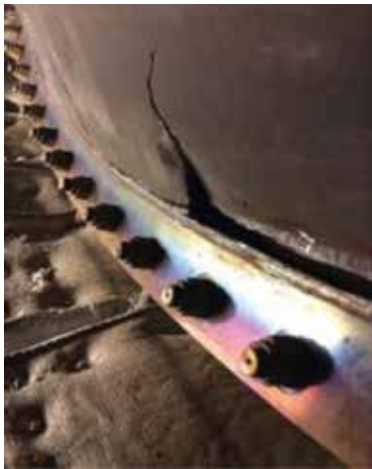
Timely turbine exhaust repairs are important for keeping O&M costs in check

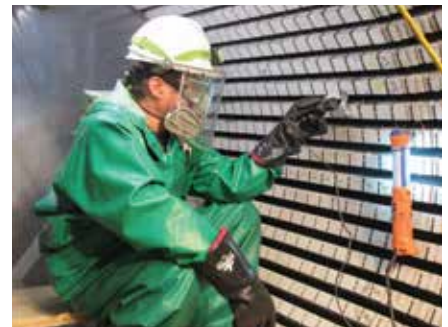
National Electric Coil. Focus is the Siemens Aeropac I, with Aeropac II, TLRI, and Westac also covered; Brush BDAX units; and Alstom GVPI. Photo shows GVPI stator-core cleaning and preparation

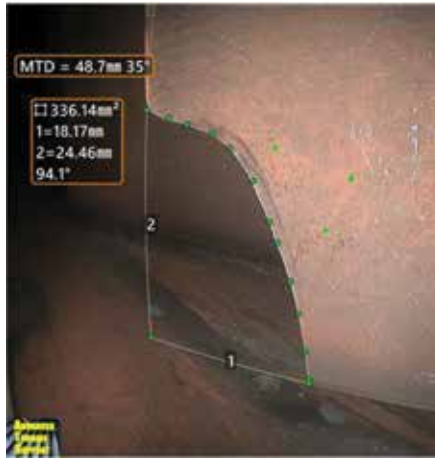
Advanced Turbine Support. In-situ blending mitigates the possibility of further damage, saves time and money by minimizing the extent of unit disassembly required

However, inspection was not the topic of Hoogsteden's presentation in the 501F/501G Vendorama program. Rather, he discussed the value to owner/operators of in-situ blending for repairing damaged airfoils. Hoogsteden began by reminding participants that the purpose of blade blending is to remove stress concentrations or cracks

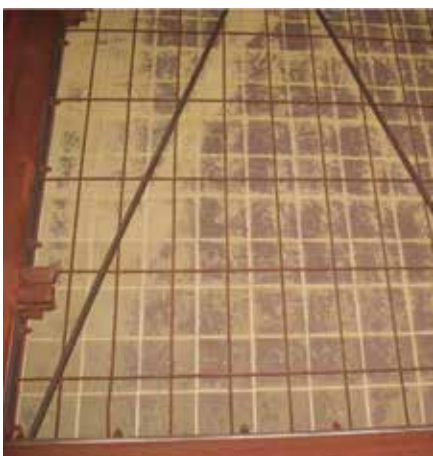
Environex. Proactive SCR/CO system management benefits include lower emissions and operating cost

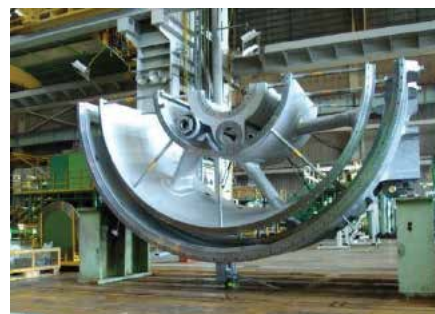
Doosan Turbomachinery Services. New exhaust cylinders (standard two-piece configuration) and exhaust manifolds in production enable in-kind replacement with DTS enhancements

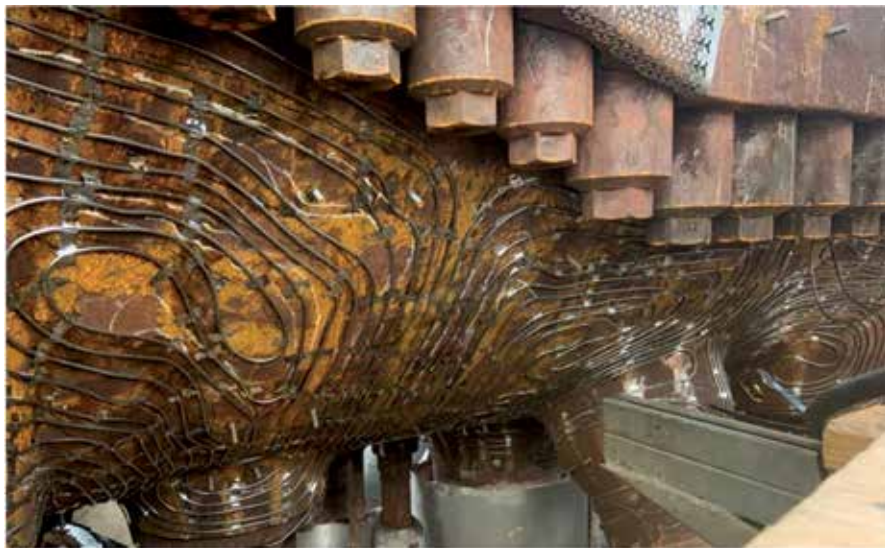
ARNOLD Group. Permanent placement of redundant sets of heating wires on the casing below the split line, plus the use of a heat-reflecting

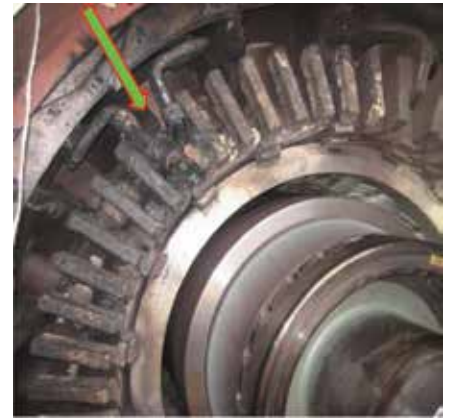
Sulzer. Rotor arrangement for a W501FD2 shows locations of problem areas noted in the company’s presentation discussing its repeatable repairs and solutions

- Broken alignment fits of the forward stub shaft.
- Compressor through-bolt failures.

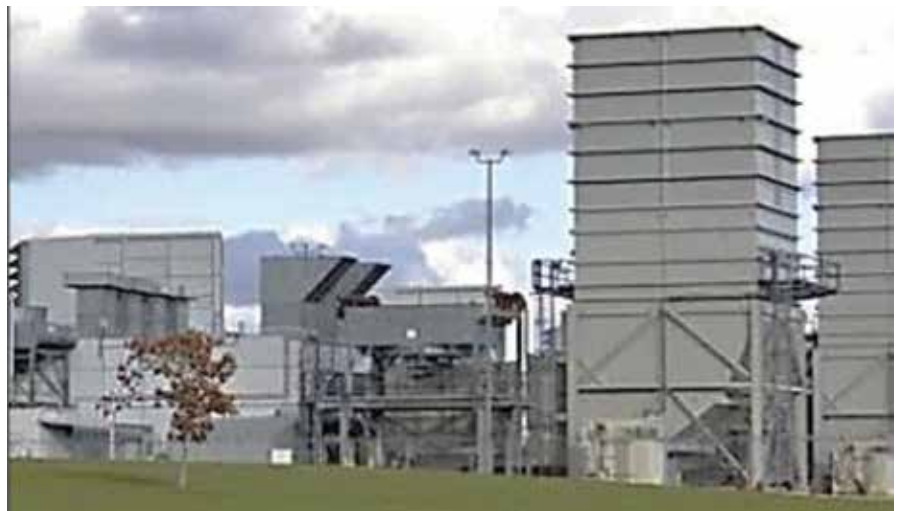
SVI/Bremco’s presentation demonstrates reliable ways to upgrade simple-cycle-turbine intake and exhaust systems using one-dimensional algorithms, CFD, and other methods

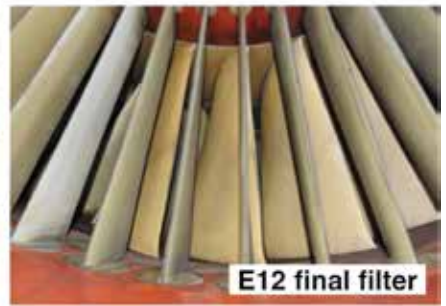
EMW filtertechnik GmbH. The positive impact filtration has on compressor cleanliness is visually evident here. Each photo shows deposits on blades in the same compressor after 5000 hr of operation

- Improved filtration minimizes the degradation of gas-turbine components and is conducive to maximizing power production and the possibility of receiving capacity bonuses.
- Efficient filters contribute to higher combustion efficiency, thereby saving fuel, reducing emissions, and potentially reducing heat rate.
- The number of compressor water washes required is reduced, increasing unit availability.

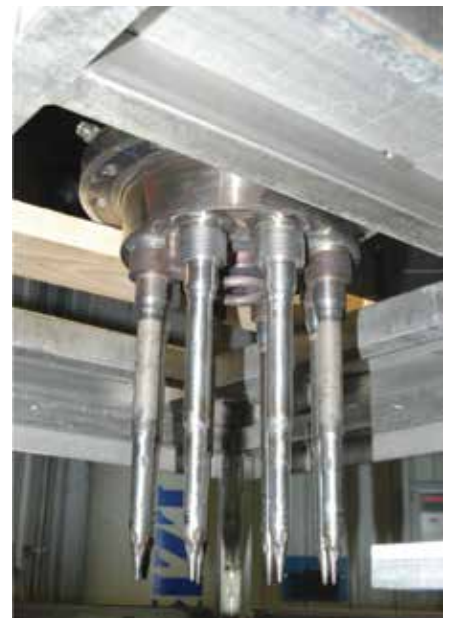
Sulzer's standard process for checking fuel nozzles during overhauls includes visual and dimensional checks, flow testing, cleaning, and dye-pen, x-ray, and borescope inspections

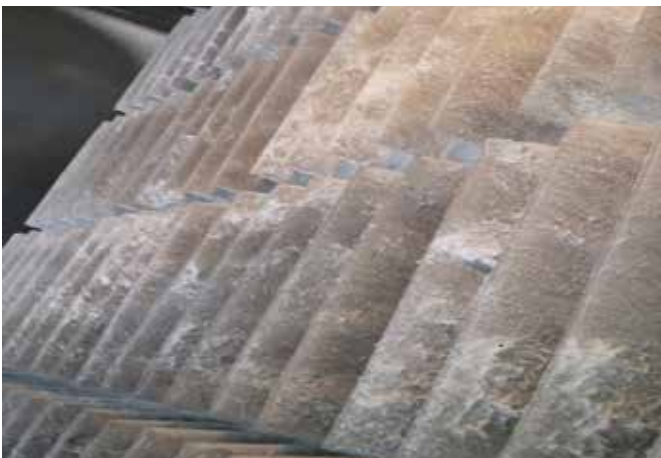
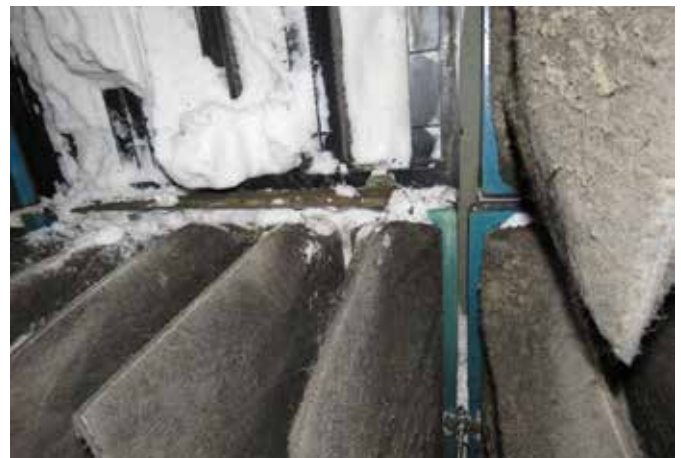
1. Snow buildup on GT-inlet prefilters is at left, snow plugging the final filter at right

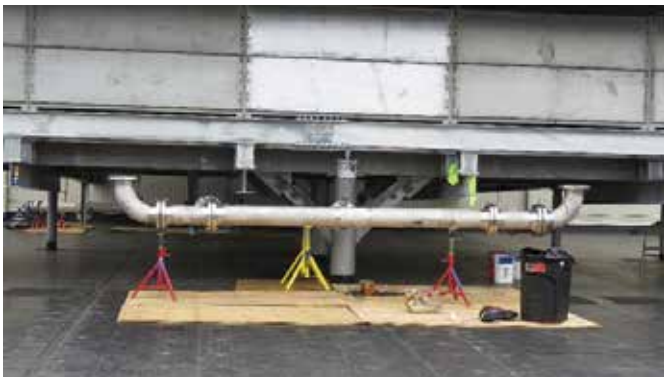
2. Anti-icing header is located below the filter house

anti-icing system that would tee off the existing compressor inlet-bleed-heat (IBH) system. The system tees into the IBH piping upstream of the OEM's block valve inside the gas-turbine package (Fig 2). The anti-icing system, when in service, directs air from the GT's compressor to the front of its inlet prefilters via an array of patented stainless-steel nozzles.

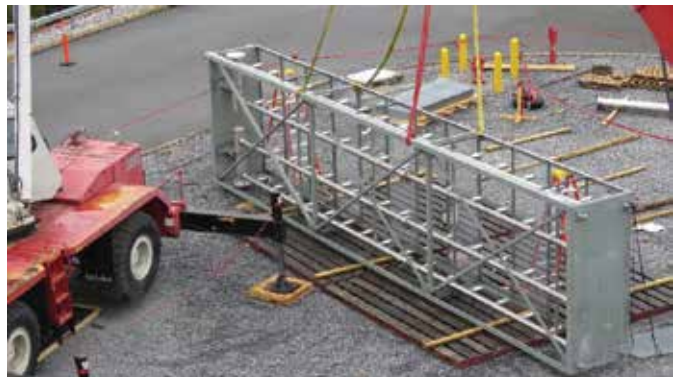
3. Anti-icing module is ready for installation

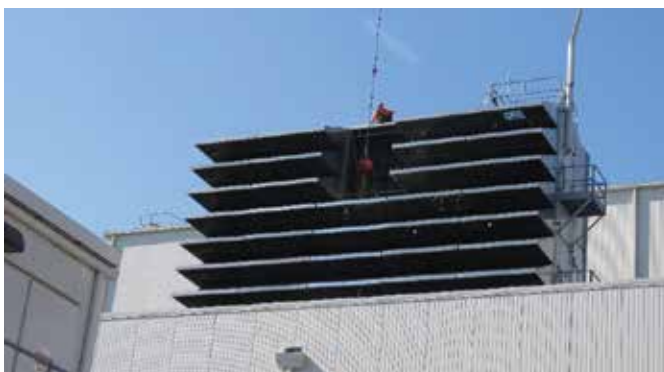
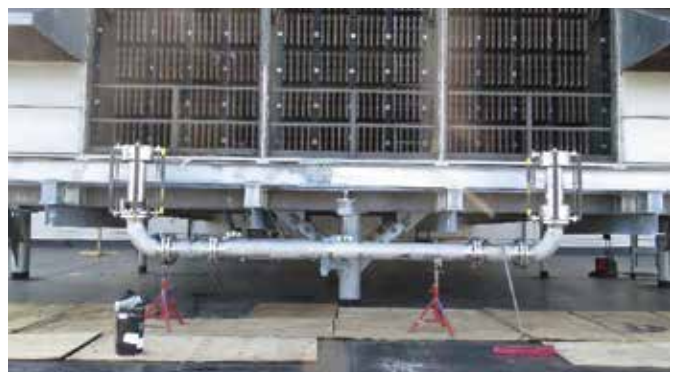
4. Snow hoods (left) were removed (right) to accommodate the anti-icing module

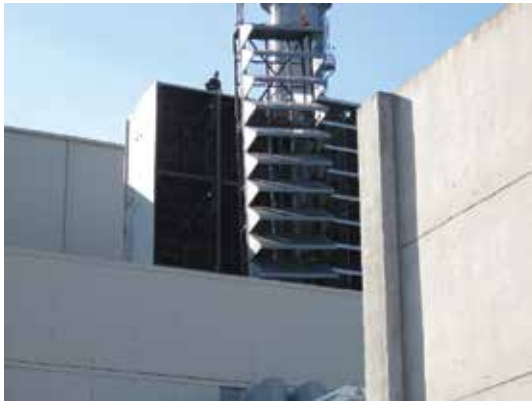
5. Anti-icing module is lowered by crane for installation in the filter house

Structural steel was added to support addition of the modules. In total, five 9 × 45-ft modules were added to each inlet house (Fig 4). The modules were flown to the roof using a crane (Fig 5) and then bolted

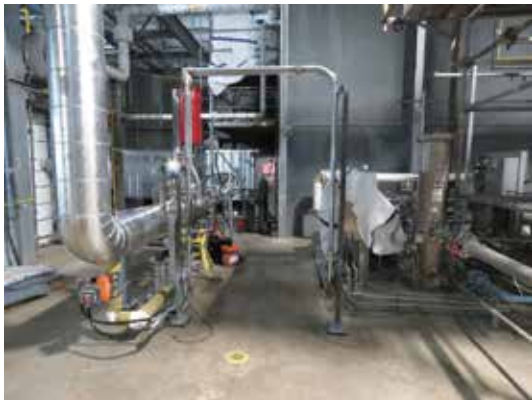
6. Control valve and instrumentation underpin the anti-icing system

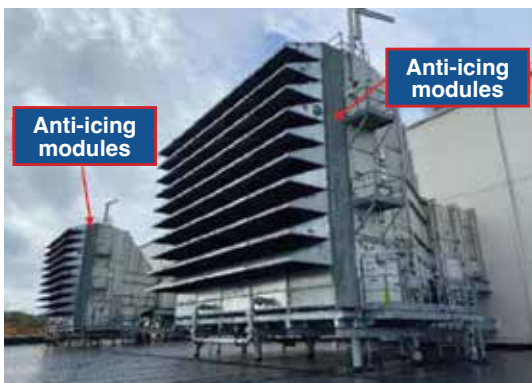
7. Anti-icing modules installed

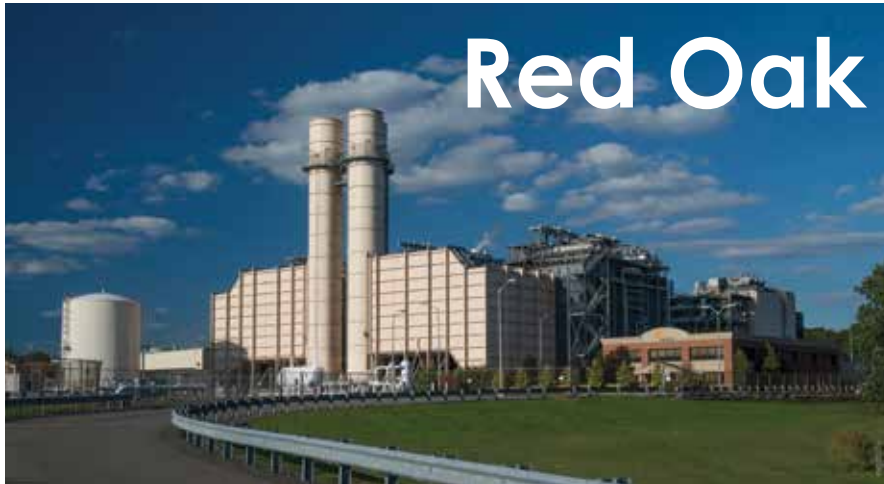
9. MPW Industrial Services' BOOM system provides CPV Valley filtered water from a waste-liquid resource. It removes TSS, organics, iron, manganese, and other contaminants. BOOM came fully automated with continuous monitoring instrumentation to ensure optimal operation

dustrial companies can lack solutions to fit their specific needs. MPW Industrial Services provided CPV Valley a fully managed system that delivered a dependable clean water supply to the plant. It is referred to internally as the BOOM (Build, Own, Operate, Maintain) water system.

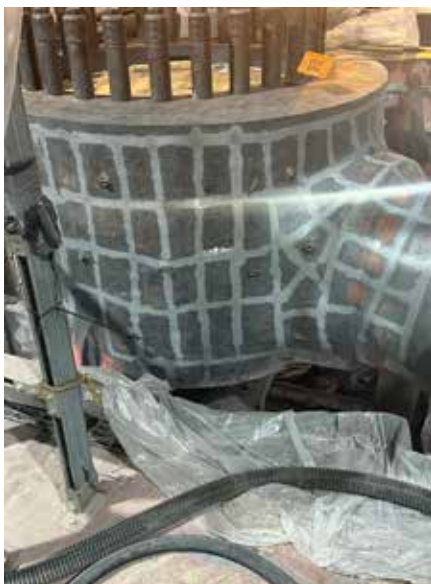
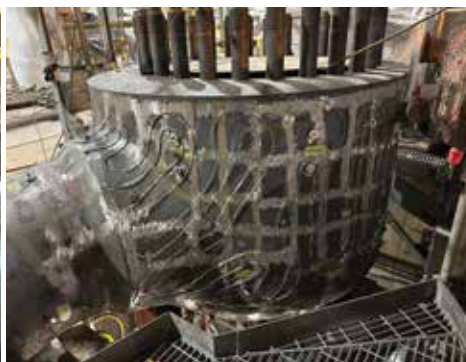
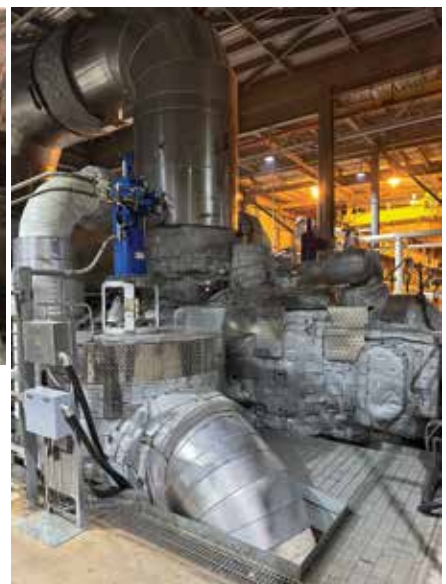
1. Planned layout of the valve warming system begins with the grid illustrated at the left. Installation of the heating coil (center) is next. Insulated valve is at right with step protection

Red Oak was responsible for removing old insulation and pins before the casing was ice-blasted clean. Next, Arnold technicians installed the high-tech warming/insulation system on the main steam valve (Fig 1) and turbine (Fig 2). After post-outage testing of the STG, Red Oak and Arnold personnel commissioned the warming system, which maintained turbine metal temperatures at the optimal level for startup.

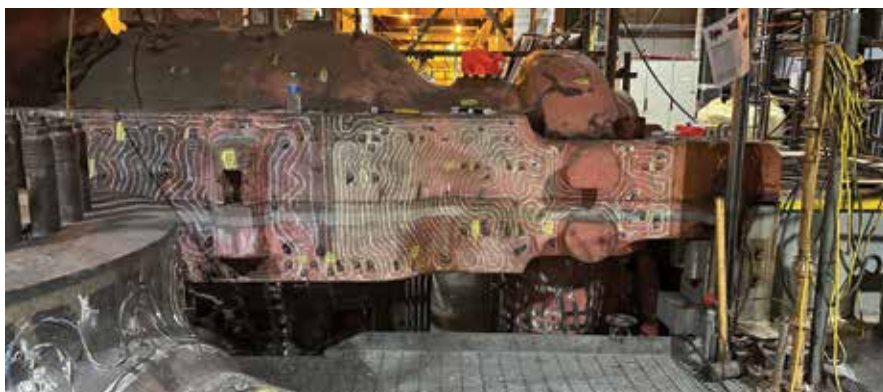
2. Heating wires installed on the steam-turbine casing at the split line

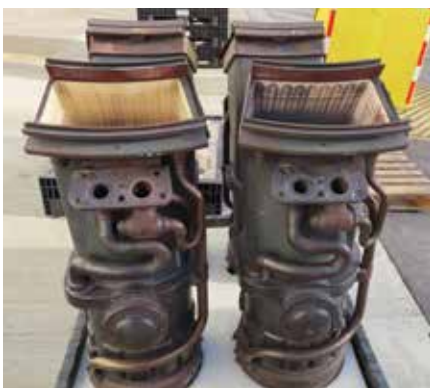
1. Steam piping is clearly visible on the transition pieces

Background. The Millennium W501G is equipped with steam-cooled transition pieces which allow the gas turbine to run at higher combustion temperatures than possible without such cooling (Fig 1).

The spent coolant is returned to the reheat steam system, thereby improving plant efficiency. Note that the steam piping, located inside the GT enclosure, is flanged for ease of disassembly during outages.

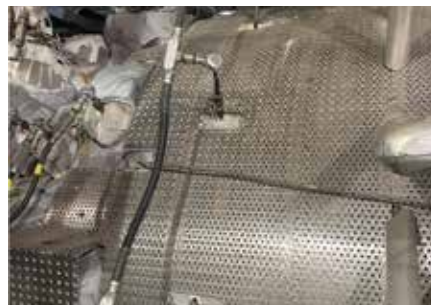
2. Thermocouples monitor average blade-path temperature

average blade-path temperature (Fig 2). They also track the temperature differences among combustors, protecting the GT in the event of a high a temperature spread. Wiring for the t/c runs in conduit and is terminated in junction boxes located next to the pipe flanges.

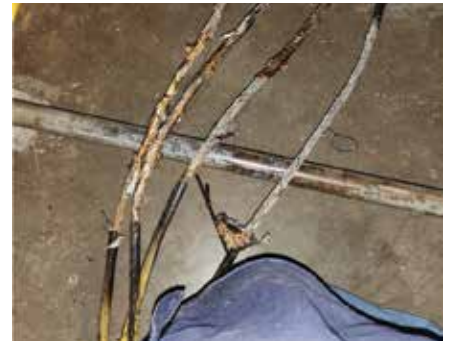
3. Leak in the transition-piece steam supply system damaged thermocouple wiring

Second: Experience led the team to focus on the leaking flange. Staff believed the most likely cause of the leak was a loss of load on the flange bolts. The team had prior success using Belleville-spring washers to resolve similar flange issues. The decision was made to install them on the TP steam

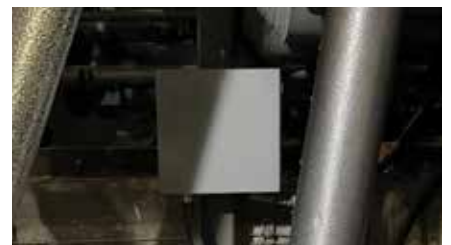
4. Junction box was relocated to keep t/c wiring out of harm's way

Solution. Plant staff collaborated to develop a permanent, long-term solution. First step was to relocate the junction box under the machine, keeping the conduit and wiring

clear of the TP steam flanges (Fig 4).

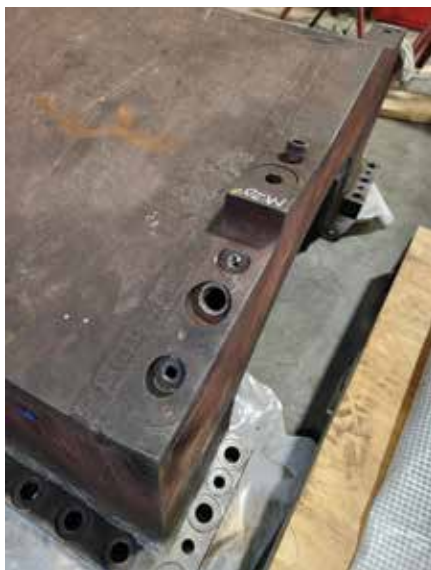
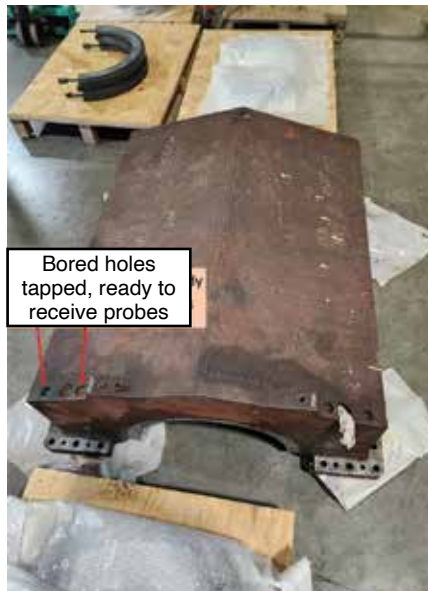
Bored holes for seismic probes as found after cover lift (left), holes tapped and ready to install seismic probes (center), locations of the original probes and additional probe (right)

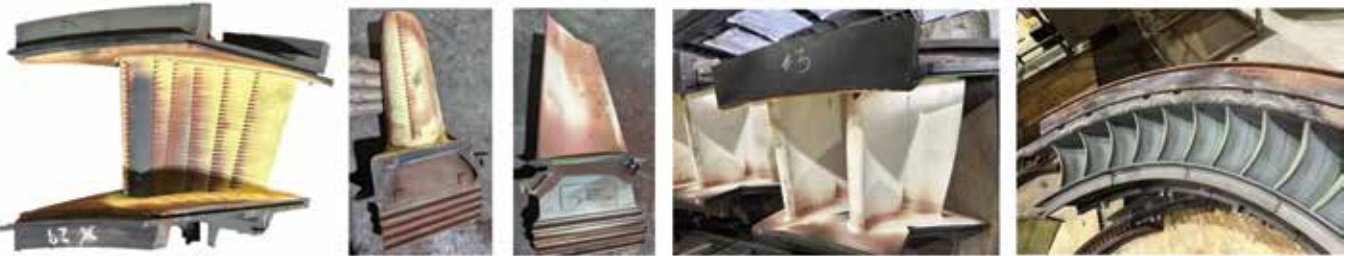
4. Critical GTOP7 components were in excellent condition after their first interval (more than 25,000 factored fired hours)

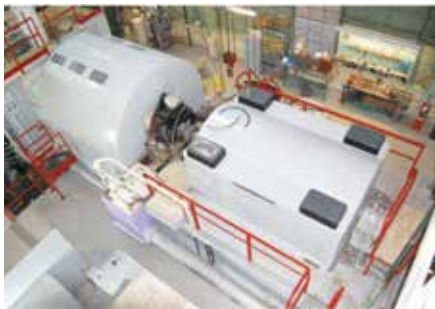
4. Looking down at the combined cycle the gas turbine is at the left, generator at the right

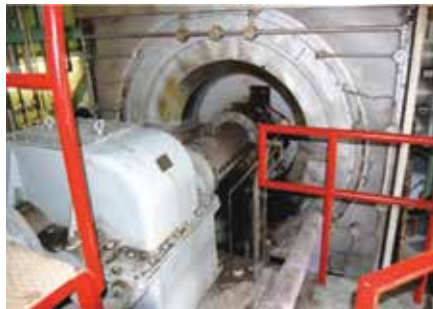
5. Gas-turbine exhaust end is to the right of the reduction gear

which operates at a nominal 6000 rpm at rated load, is connected to the 3600-rpm generator through the reduction gear shown in Fig 5. The generator is rated 13.5 MVA, 12.5 kV, 0.85 pf.

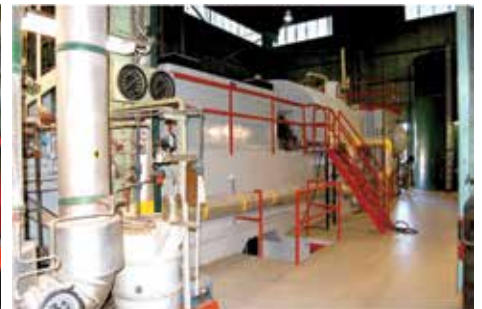
6. Generator is at the left, steam turbine and condenser at the right, looking down the combined cycle on the operating floor

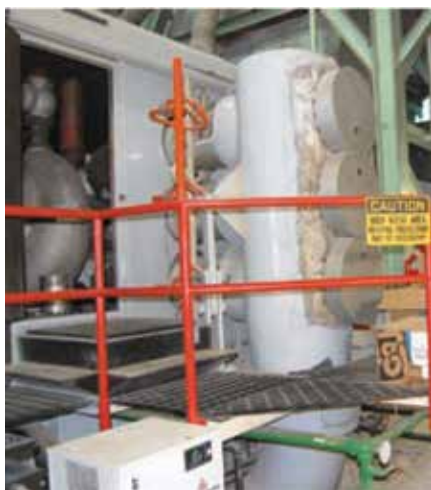
7. One combustor manifold is located on either side of the engine

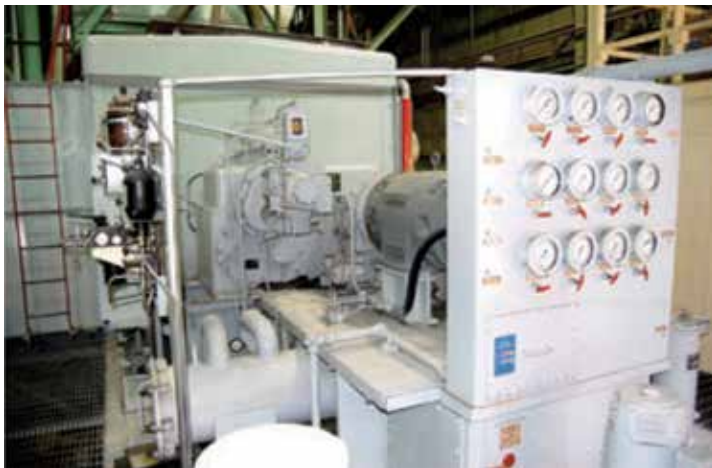
8. Accessory base contains the auxiliaries for starting and operating the gas turbine

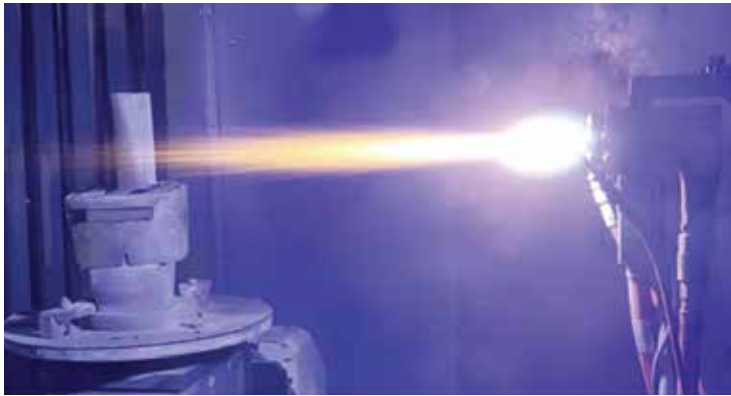
2. Air plasma spraying of a first-stage bucket

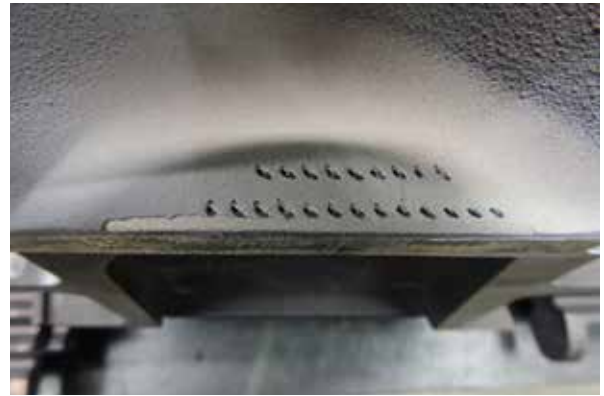
4. TBC top-coat spallation at this S1B's platform edge prior to installation

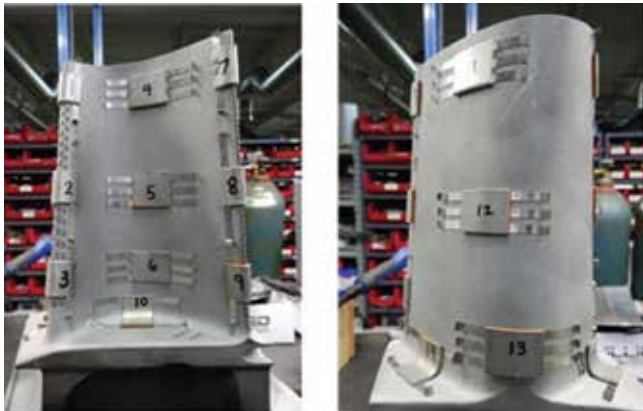
3. Use of tabs allow use of the same buckets in multiple trials

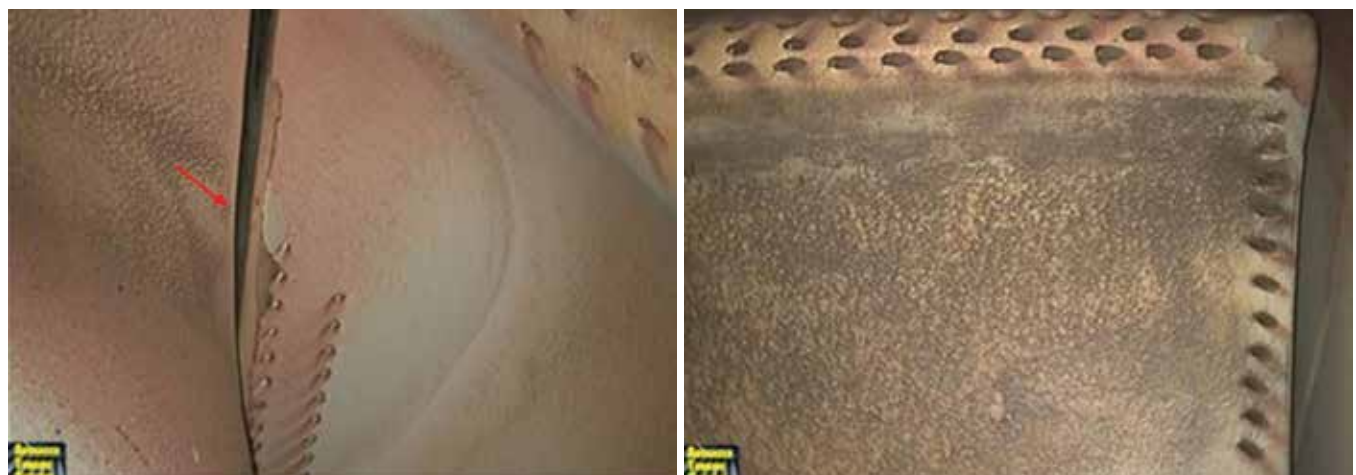
8. Coating loss at the platform edge is seen in the left-hand borescope photo; leading-edge tip coating loss and discoloration at the right

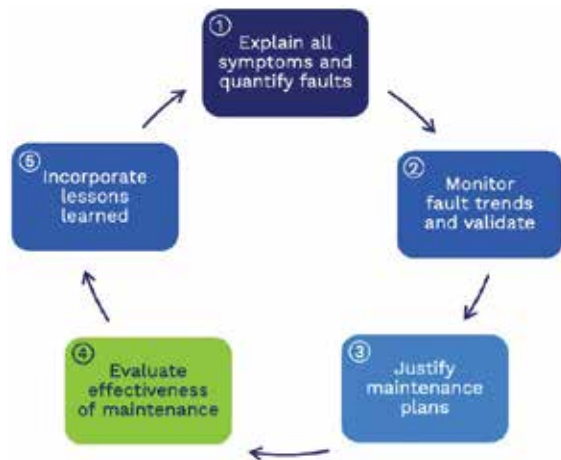
3. Simultaneous out-of-range sensor readings are matched with symptoms to give a holistic explanation of the behavior at a given time stamp, along with the impact on performance. The fault diagnostics process begins with inference results. Reliability builds trust and faster action in Steps 2-4. The process ends with continuous-improvement feedback to incorporate changes in faults and models

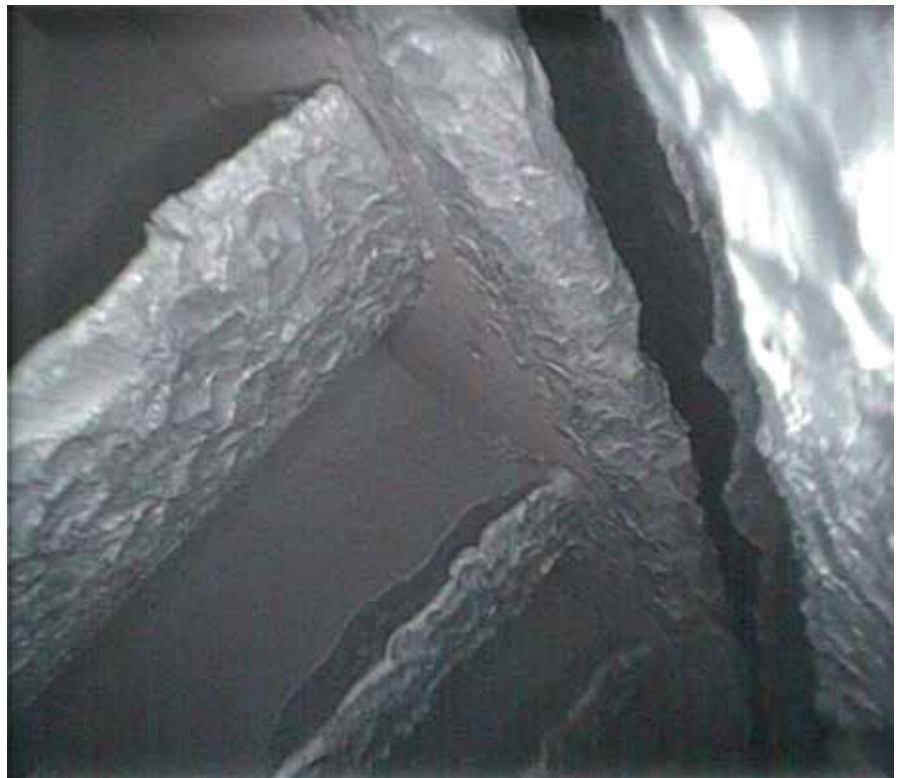
Damage to steam-turbine blades attributed to disbonded Stellite

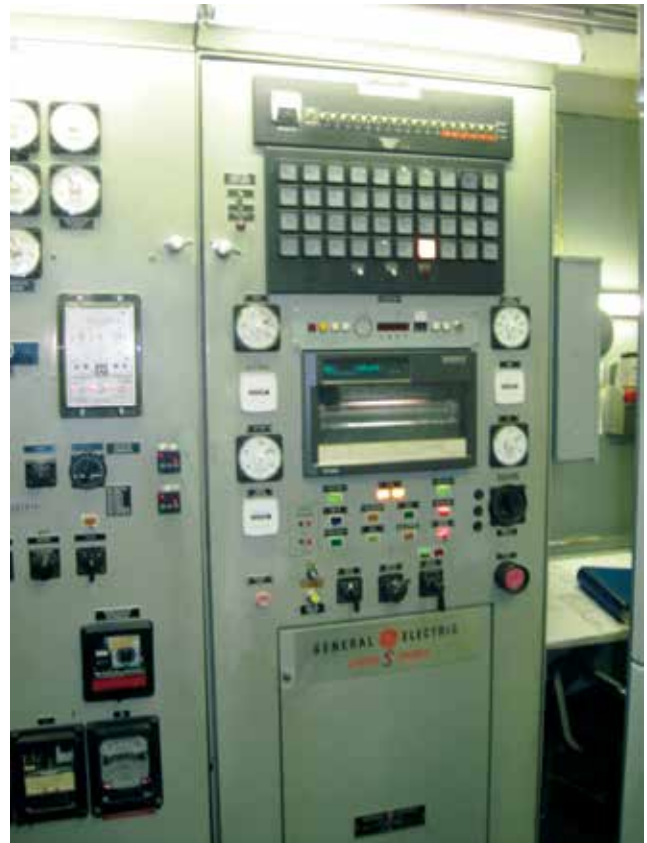
Speedtronic™ Mark I control systems were installed on gas turbines in the early 1970s, primarily on MS5001N and MS7001B engines

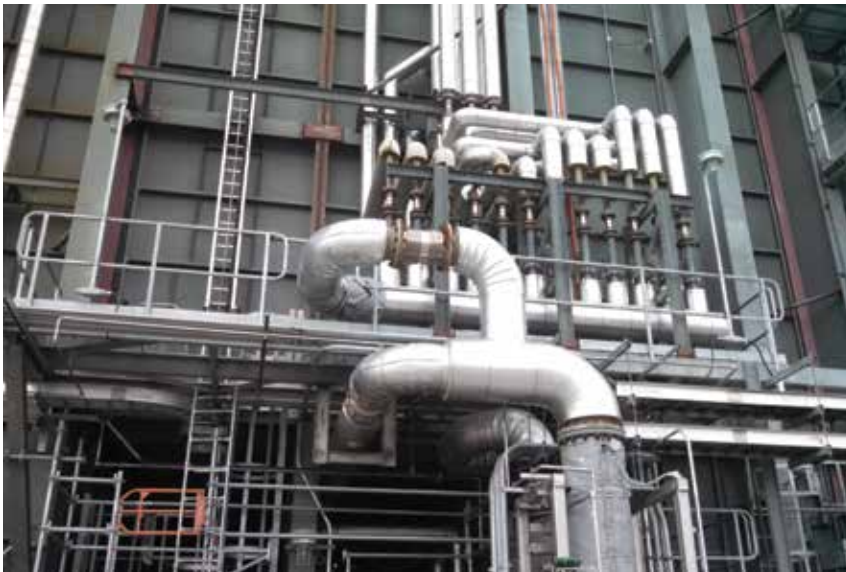
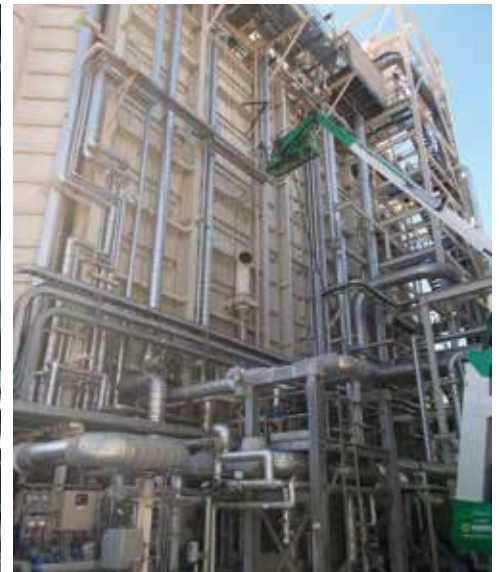
1, 2. Ammonia distribution piping to the AIG is shown at left. Control zones should be able to adjust ammonia in sections of the ductwork. Photo, right, illustrates traverse tuning which involves taking measurements of ammonia distribution at each of the eight AIG elevations. The more zones, the better the tuning capability

Ammonia distribution within the exhaust gas cross-section is a huge factor in the catalyst's ability to properly reduce NO_x levels (Figs 1 and 2). This important part of the system largely falls to the design of the ammonia injection grid (AIG). It must consider both the amount of ammonia and

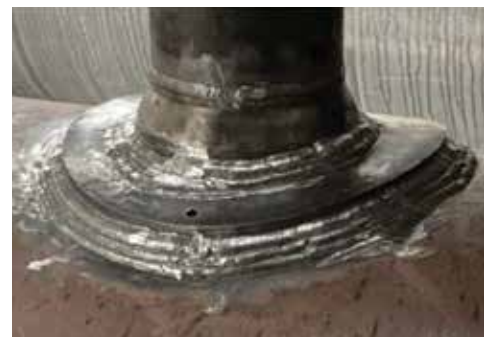
1. Nozzle welds may require reinforcement

in a recent re-rate by Vogt Power, the drum shell and head passed Code calculations under the new pressures, but the nozzle welds did not and required reinforcement weld pads (Fig 1).
